**SONOMA COUNTY FIRE DISTRICT
MOUNTAIN STATION #6**

ADDENDUM NO. 2

Sonoma CFD Station 6

Environmental Survey
for Renovation

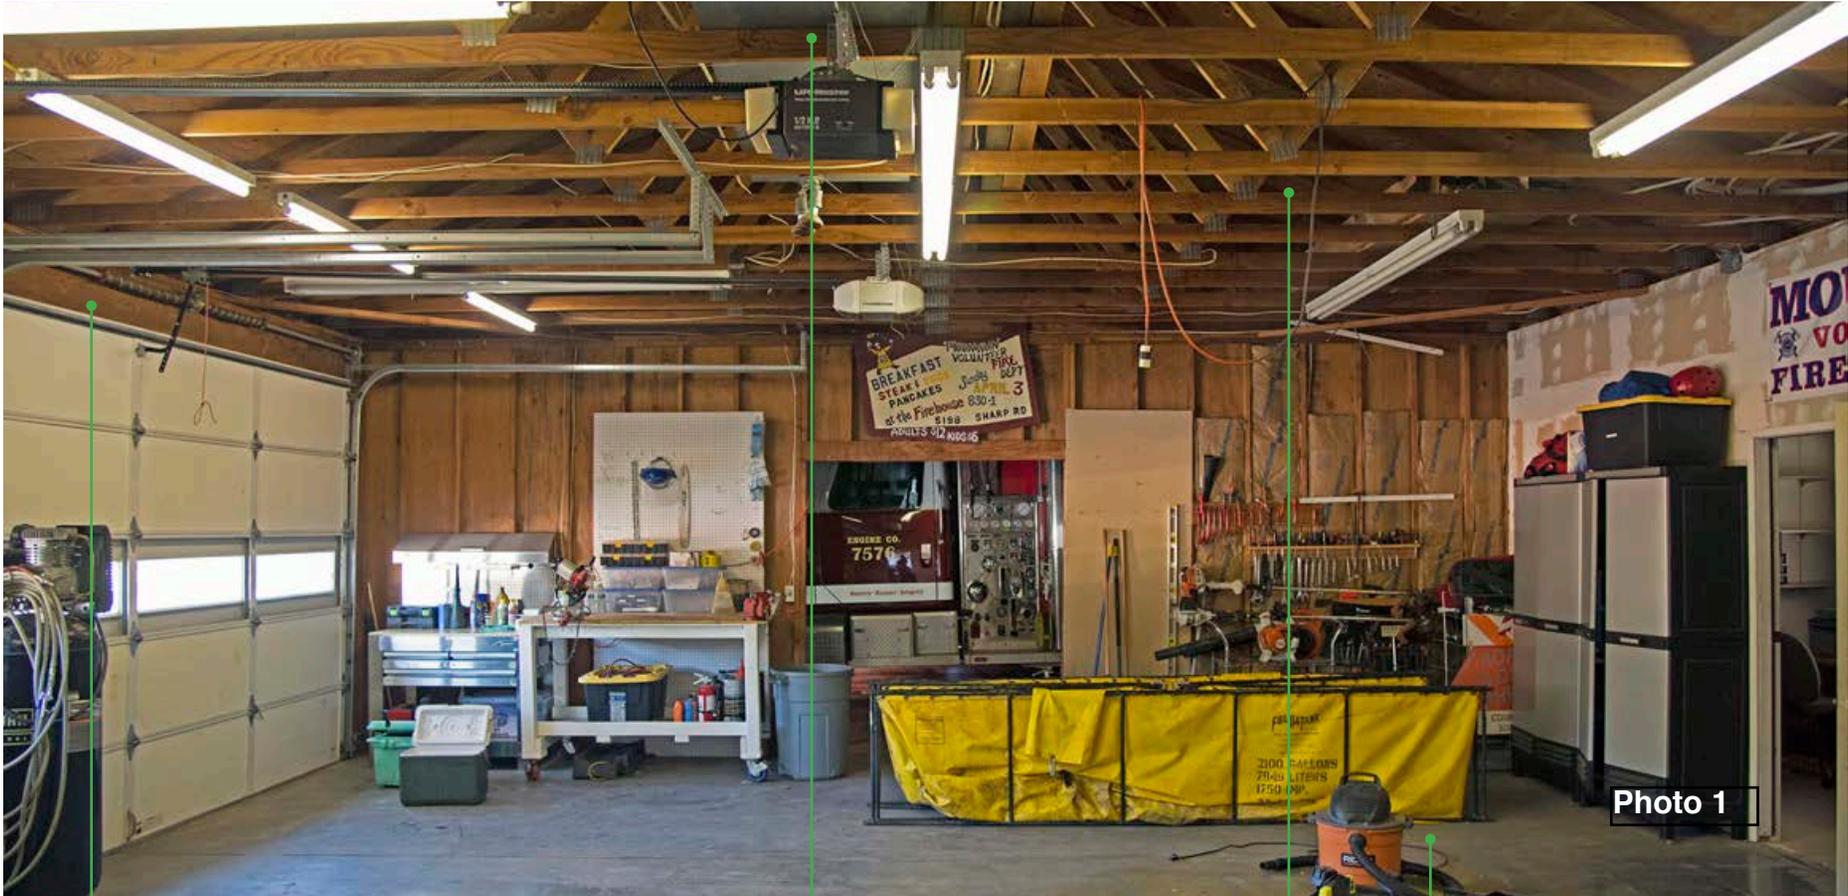
Photo 1

The perimeter / exterior walls at the apparatus room are wood siding. The roof uses wood trusses.

The roof uses composition shingles over plywood. No asbestos was found in the roof shingles or the caulking used at the roof.

Roof Materials: The roofs are composition / fiberglass shingles over a plywood deck. Minor amount of caulk / cement were found at roof jacks. The roof shingles and caulk were non detect for asbestos.

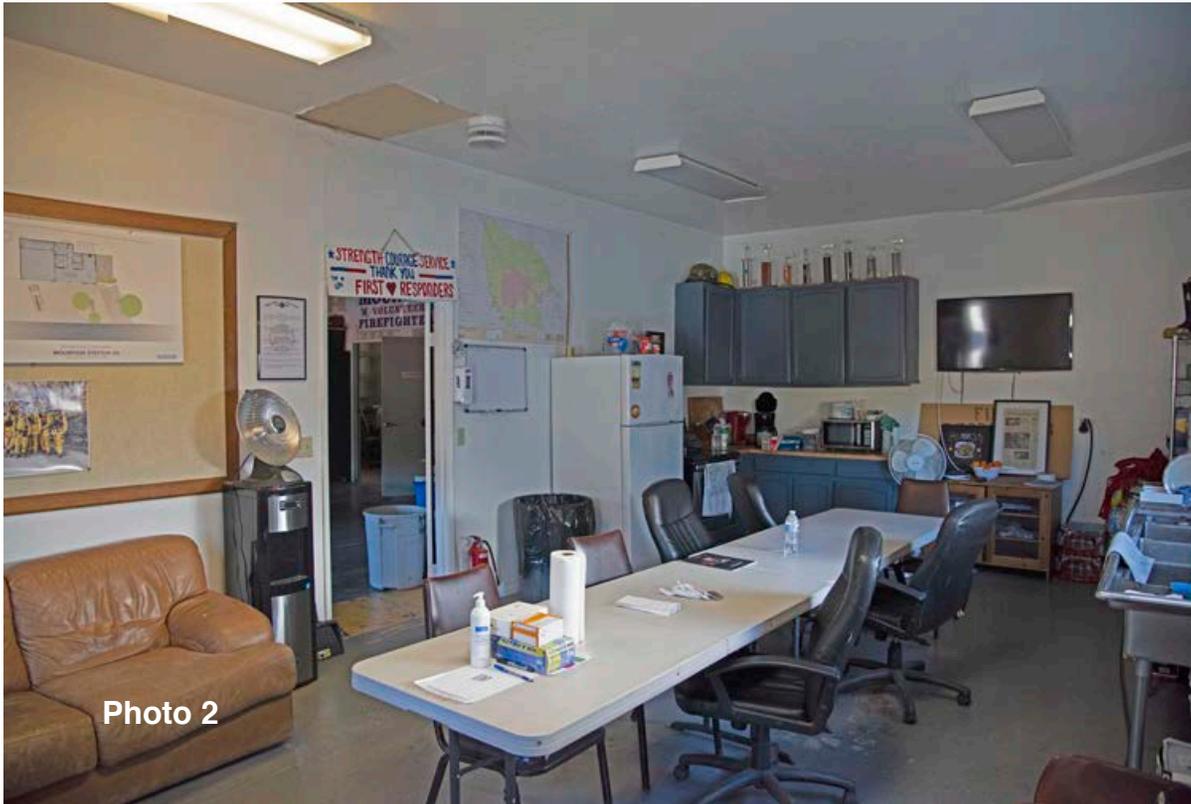
The finish materials at the interior station living spaces are consistent. The newer interior partition walls at most areas are sheathed with gypsum board, finished with joint tape compounds. The finished ceilings are the same material at all areas. The interior gypsum board, joint compound, and texture compounds are all non detect for asbestos. Photo 2 shows the station's meeting or day room. The floors are painted concrete. There is no HVAC system in the station. It is assumed that fiberglass insulation may also be found in the wall cavities and above some of the ceilings.

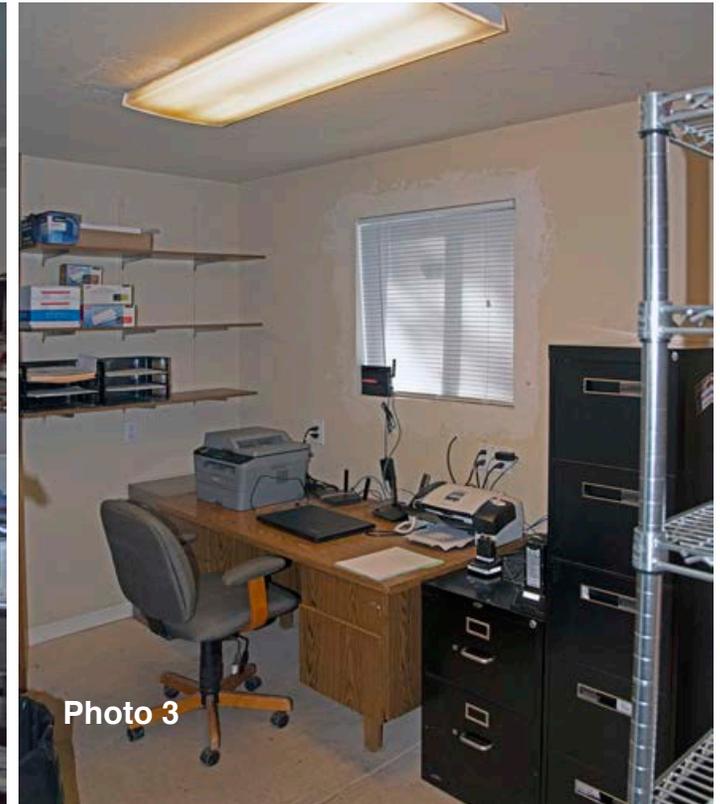
The rest room floor uses ceramic tile over a concrete slab. Photo 3 shows office / storage room with exposed concrete slab and drywall for walls and ceilings. The lighting system in many parts of the station are fluorescent lamped. The existing lamps should be recycled due to mercury content at the time of removal. The fluorescent fixtures should be checked to confirm that ballasts are labeled as "Non-PCB". The paints on the interior and exterior are in good intact condition, with only minor chipping or peeling. See the complete report.

The flooring is mostly exposed concrete slab. Minor areas of ceramic tile and grout are found in the bathroom. The floor plan indicates the locations and samples collected of these materials.

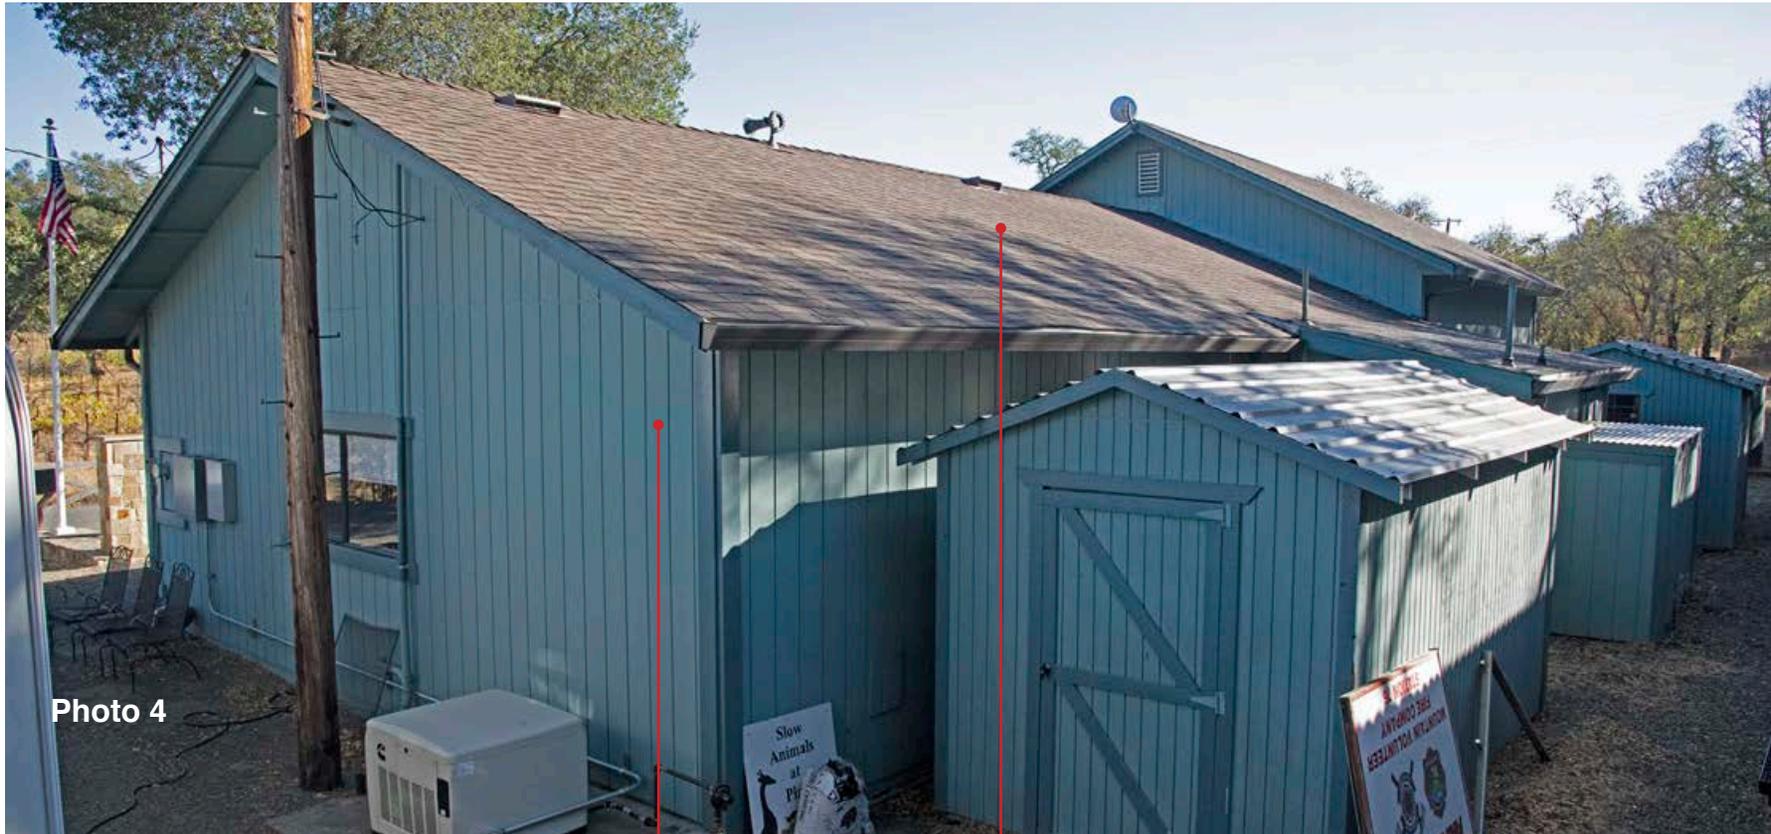
Photo 4

The exterior paints on the siding and trim components were tested for lead content at five different locations. The paint is in good condition, with minor areas of chipping, due to weathering.

During the inspection process materials were noted that may contain lead, which were a specific part of this survey. None of the exterior paints on shingles, siding, trim, soffits, etc. are found to contain substantial amounts of lead. The lead suspect materials are in good condition. Any older copper water pipes may also contain lead containing solder at joints and fittings. This is only a partial list of all the possible lead containing materials that may be present. The Cal/ OSHA and Department of Public Health regulations should be followed during demolition work. The waste from the site shall be tested using TTLC testing of composite debris from the site. This test can be at the time of removal. It is expected that the metals from the site will be recycled.

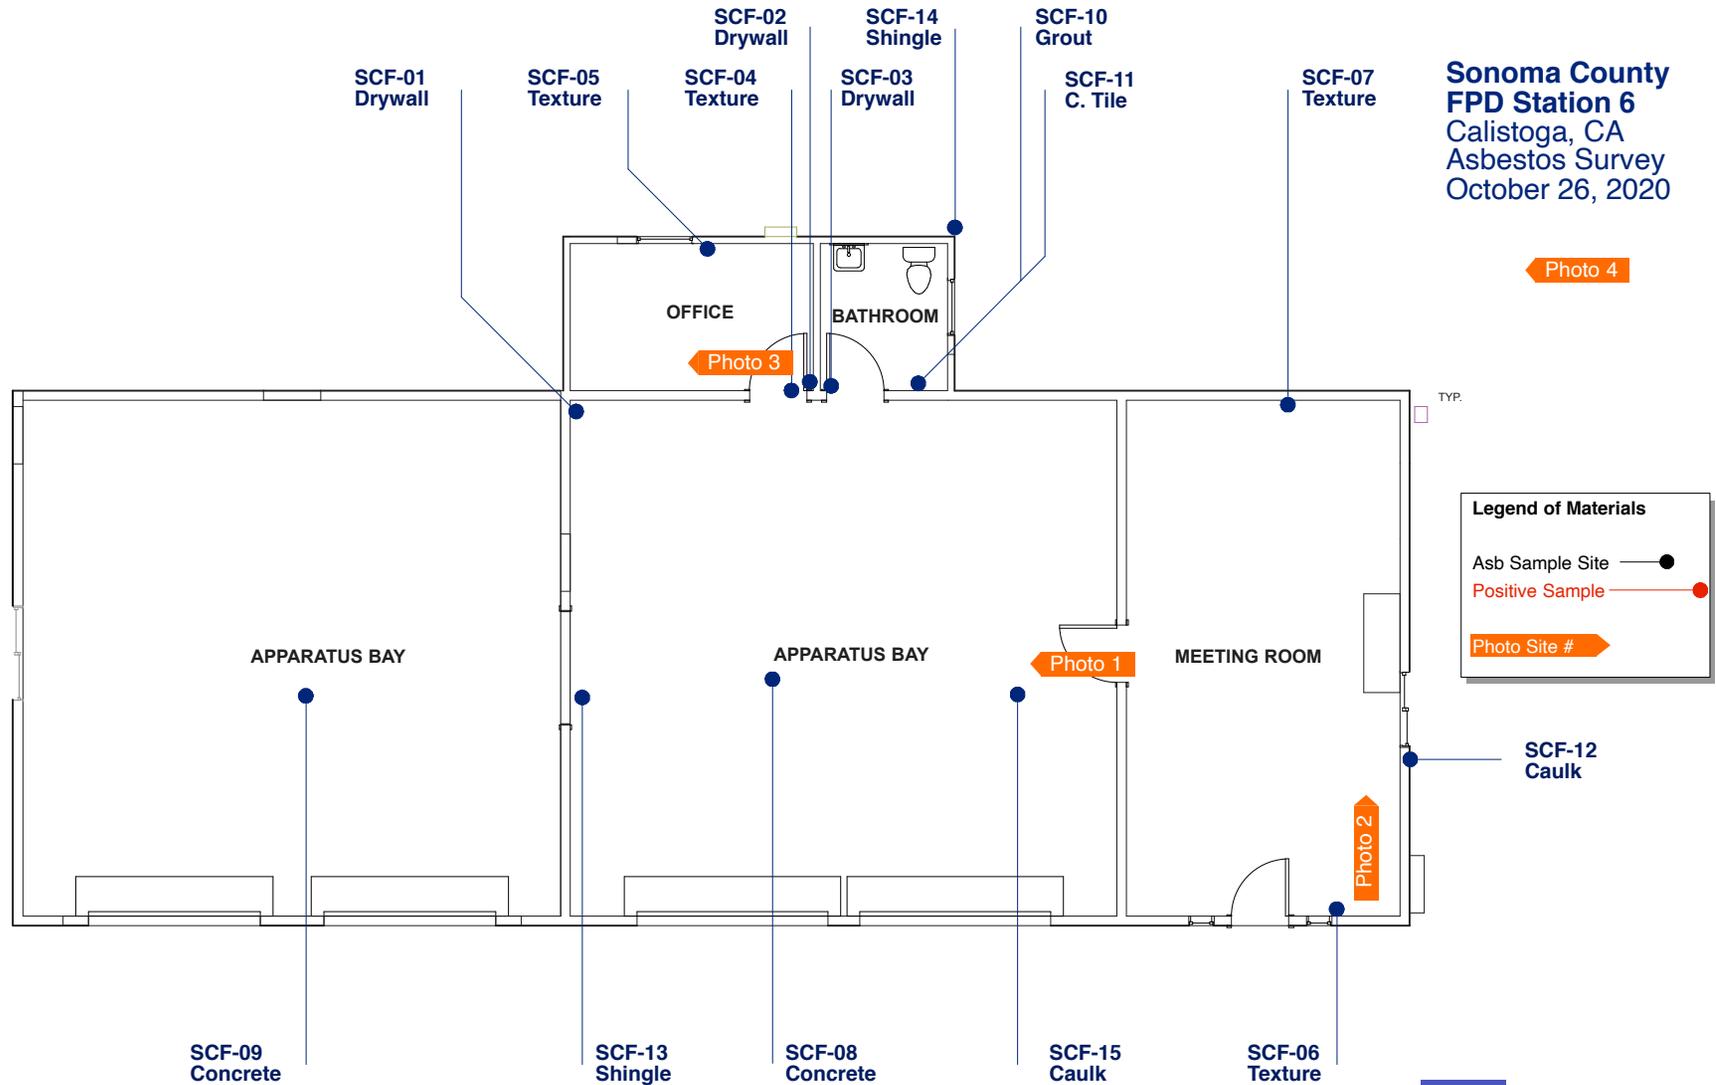
**Sonoma County
FPD Station 6**
Calistoga, CA
Asbestos Survey
October 26, 2020

Standard sampling tools and procedures were used to obtain samples from the suspected materials. The samples were bagged and submitted to the laboratory under standard chain of custody protocols. Representative sample locations were noted on the floor plans of the building

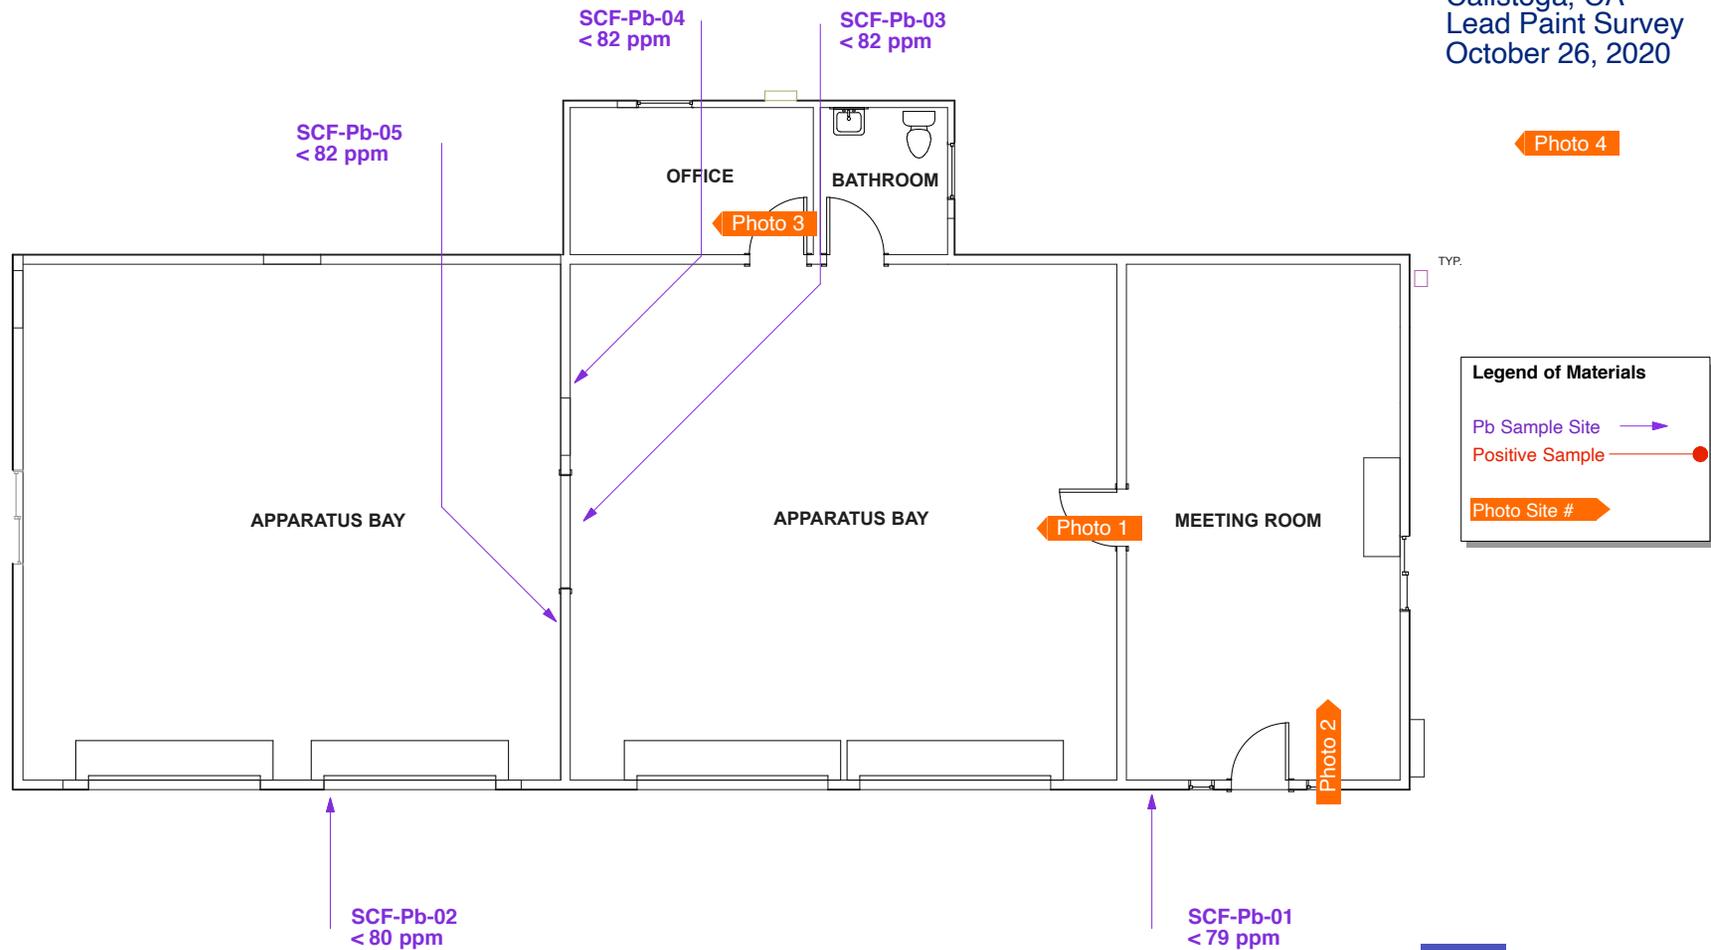
**Sonoma County
FPD Station 6**
Calistoga, CA
Lead Paint Survey
October 26, 2020

Sample ID	Lead Concentration Weight Percent	mg/kg (ppm)	RDL
Client: SCF-PB-01 Lab: 275812-01 GREEN PAINT ON WOOD SIDING AT MEETING ROOM	< 0.0079 %	< 79	0.0079 % 79 mg/kg
Client: SCF-PB-02 Lab: 275812-02 WHITE PAINT ON WOOD APPARATUS DOOR AT EAST	< 0.0080 %	< 80	0.0080 % 80 mg/kg
Client: SCF-PB-03 Lab: 275812-03 GREEN PAINT ON TRIM FACIA BOARD AT ROOF	< 0.0082 %	< 82	0.0082 % 82 mg/kg
Client: SCF-PB-04 Lab: 275812-04 GREEN PAINT ON SIDING WOOD SIDING AT ROOF	< 0.0082 %	< 82	0.0082 % 82 mg/kg
Client: SCF-PB-05 Lab: 275812-05 TAN PAINT ON WOOD WOOD SIDING AT APP. BAY	< 0.0082 %	< 82	0.0082 % 82 mg/kg
